# **Gay Head Light Station Martha's Vineyard, Massachusetts**

UNITED STATES COAST GUARD, FIRST DISTRICT  
LIGHTHOUSE PROTECTION STUDIES, NEW ENGLAND

GAY HEAD LIGHT STATION  
MARTHA'S VINEYARD, MASSACHUSETTS

AUGUST 1989

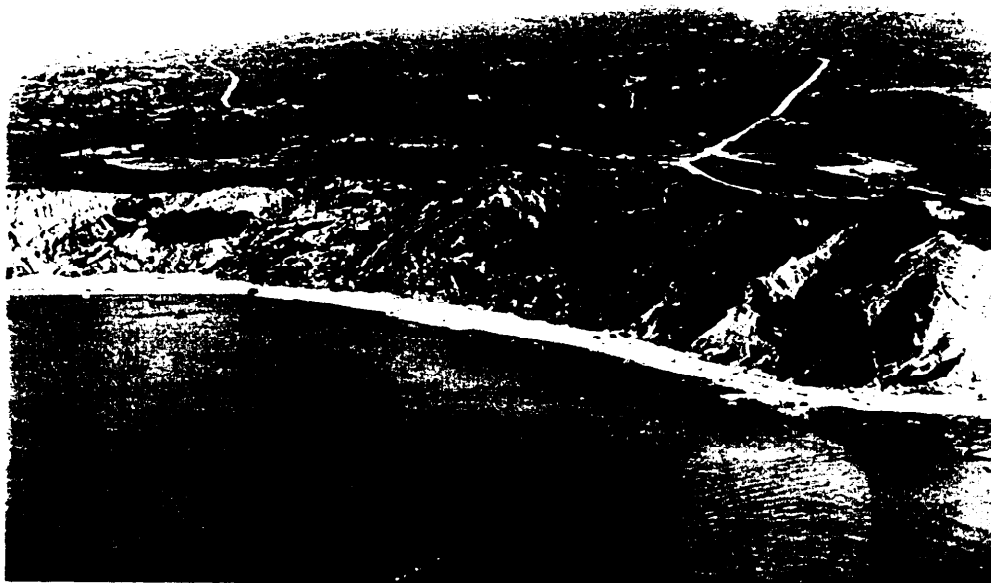
PHOTO 4  
SCARS OF MAJOR LANDSLIDES AT GAY HEAD

The 1973 Corps of Engineers report cited previously suggests that the major landslides were formed by either of two different processes. They all began as massive landslides and then continued cliff recession proceeded with a succession of smaller landslides which are confined to the upper slopes above the debris terraces. Subsurface drainage and seepage most probably are major contributing factors to the upper slope landslides. Other landslides develop as the bottom of the cliffs are undermined by wave erosion or piping by water seepage or by mudflows.

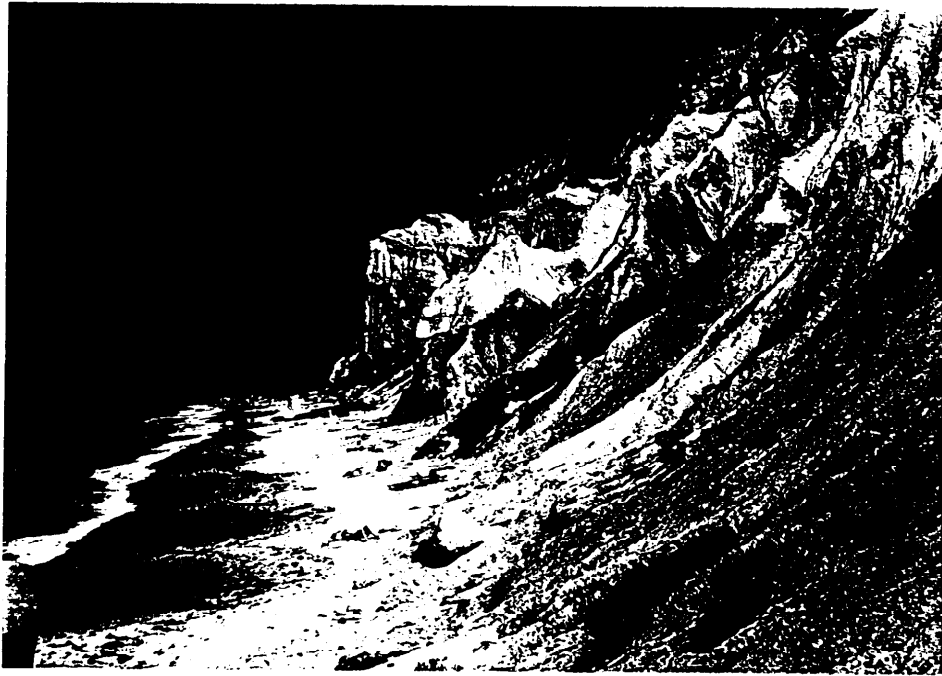
PHOTO 5  
MATERIAL AT BOTTOM OF CLIFFS IS REMOVED BY WAVE ACTION

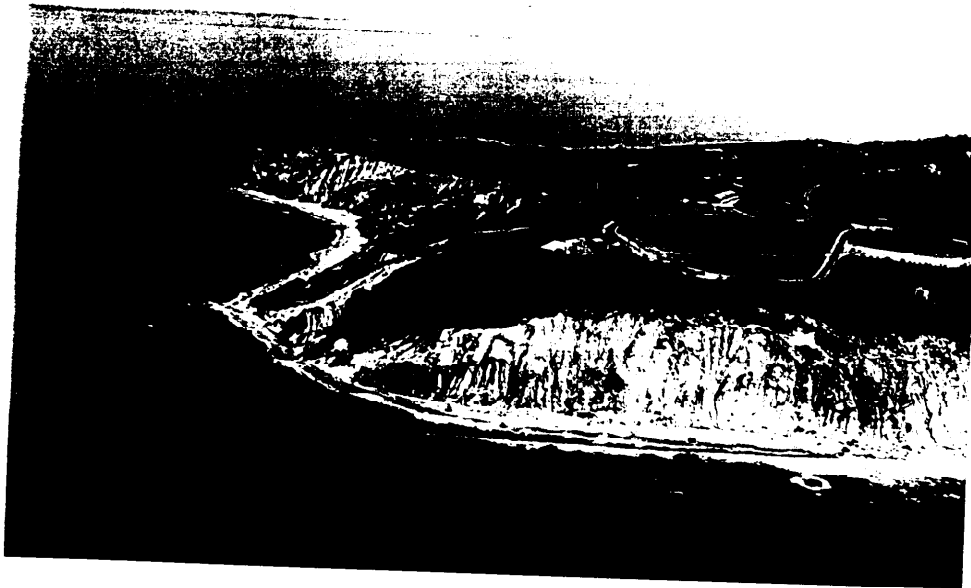
Clearly the most critical area in terms of imminent potential danger to the Gay Head Light is the cliff edge to the west of the lighthouse formed by the rear scarp of Landslide IV (see map, Plate 2). The light at that point is approximately 55 feet from the cliff edge. (See Photo 6.) At that distance, assuming an average rate of erosion of 1 to 3 feet per year, (see section on cliff recession for derivation of this rate) the lighthouse will

PHOTO 6  
LIGHT STRUCTURE APPROXIMATELY 55 FEET FROM CLIFF EDGE

be lost to erosion in 25 to 50 years. The magnitude of the risk increases substantially when taking into account the probability of a catastrophic erosional event during which many feet of cliff might suddenly fall.
